Rapid Assessment of October 2025 Flooding in Southwest Colorado

Authors: Nels Bjarke and Seth Arens

WESTERN WATER
ASSESSMENT
A NOAA CAP/RISA TEAM

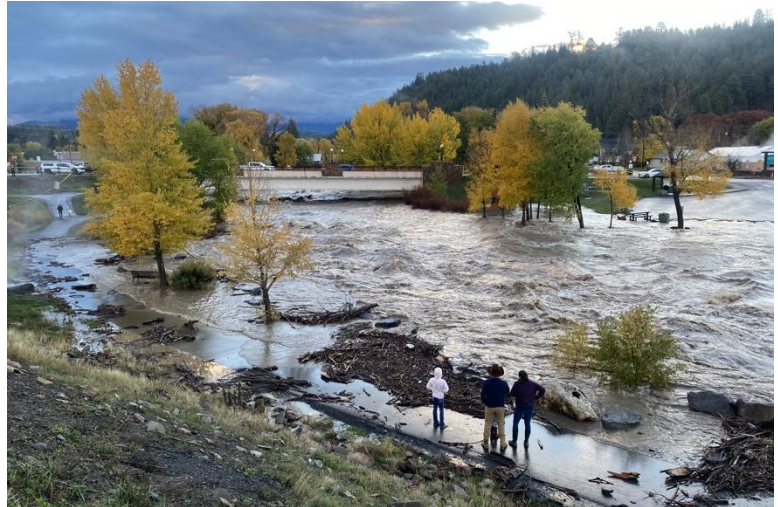
October 2025 flooding of the San Juan River at Pagosa Springs. Photo courtesy of Randi Pierce and The Pagosa Springs Sun¹

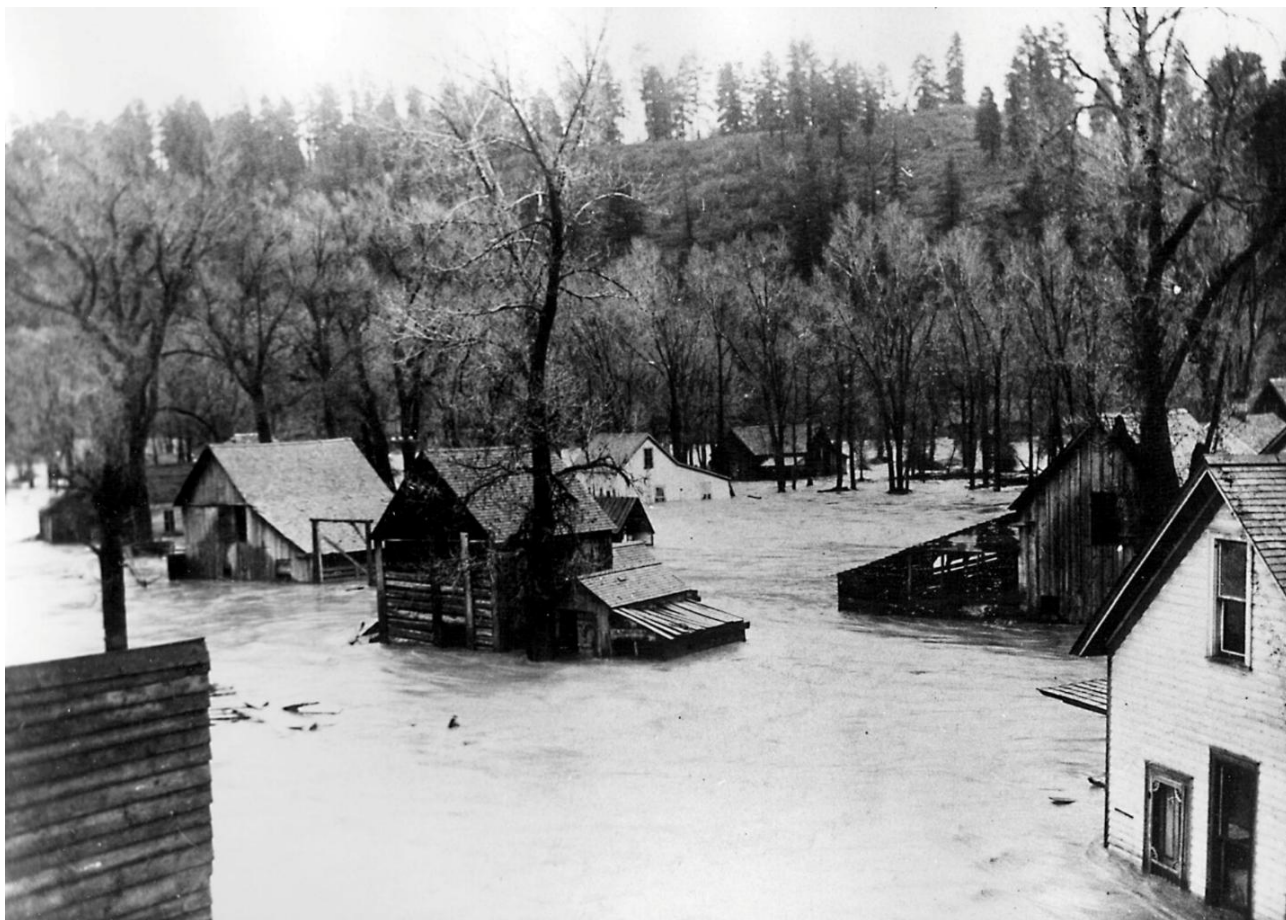
The October 1911 flood of the San Juan River in Pagosa Springs flooded many homes as the river crested at nearly 18 feet. (The Pagosa Springs Sun, October 16th, 2025)¹

Only three floods in Pagosa Springs have exceeded the minor flood stage of 10.5 feet: the flood of record in 1911, and floods in 1927 and 2025. The 1911, 1927, and 2025 floods crested at heights of 17.8, 13.5, and 12.8 feet. Little information is available about impacts of the 1927 flood, but the 1911 flood washed out the bridge and destroyed 20 structures in Pagosa Springs.

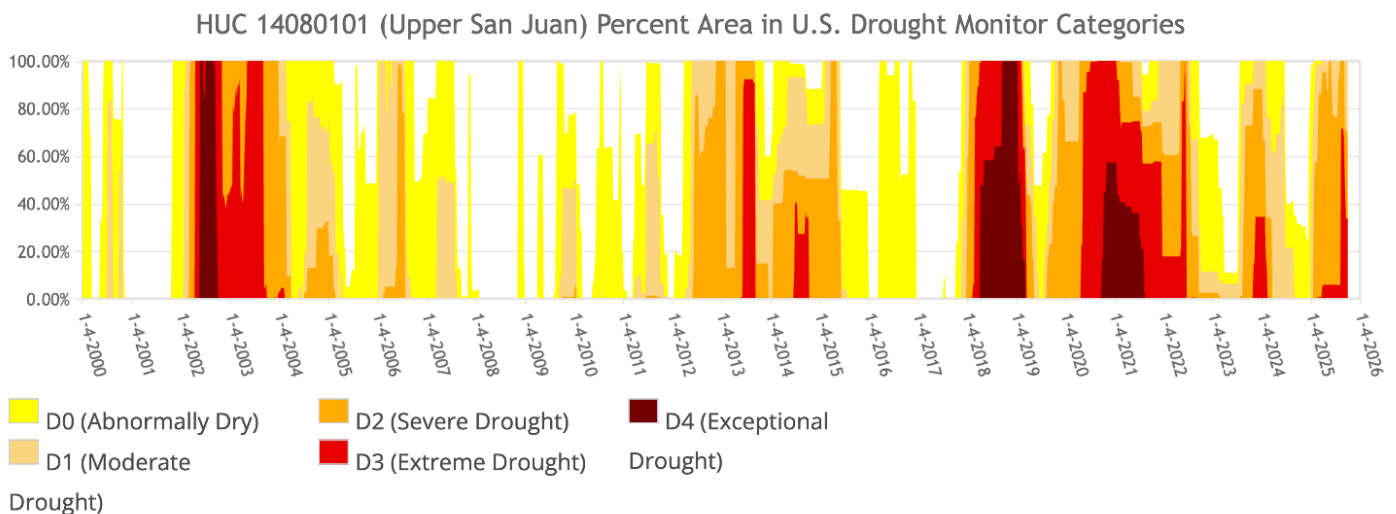
Figure 2. U.S. Drought Monitor time series (2000-2025) for the Upper San Juan River basin. Drought categories indicate the relative dryness of the atmosphere and land-surface compared to the historical record using a convergence of evidence approach developed by the U.S. Drought Monitor. (USDM Time Series, <https://droughtmonitor.unl.edu/DmData/TimeSeries.aspx>) The U.S. Drought Monitor is jointly produced by the National Drought Mitigation Center at the University of Nebraska-Lincoln, the United States Department of Agriculture, and the National Oceanic and Atmospheric Administration. Map courtesy of NDMC.

The San Juan River basin above Pagosa Springs was in moderate drought, in the lowest 20th percentile of historical moisture levels, during early October 2025 (U.S. Drought Monitor, October 7th, 2025, <https://droughtmonitor.unl.edu/Maps/MapArchive.aspx>). The Millennial Drought of the Western U.S. began in 2002 and was the most intense in the Upper San Juan River basin from 2002-2007, 2012-2015 and 2018 to present (Figure 2). Many of the last eight years of drought were experienced as extreme to exceptional drought in the basin, and drought was briefly alleviated during late 2024 through the early spring of 2025.

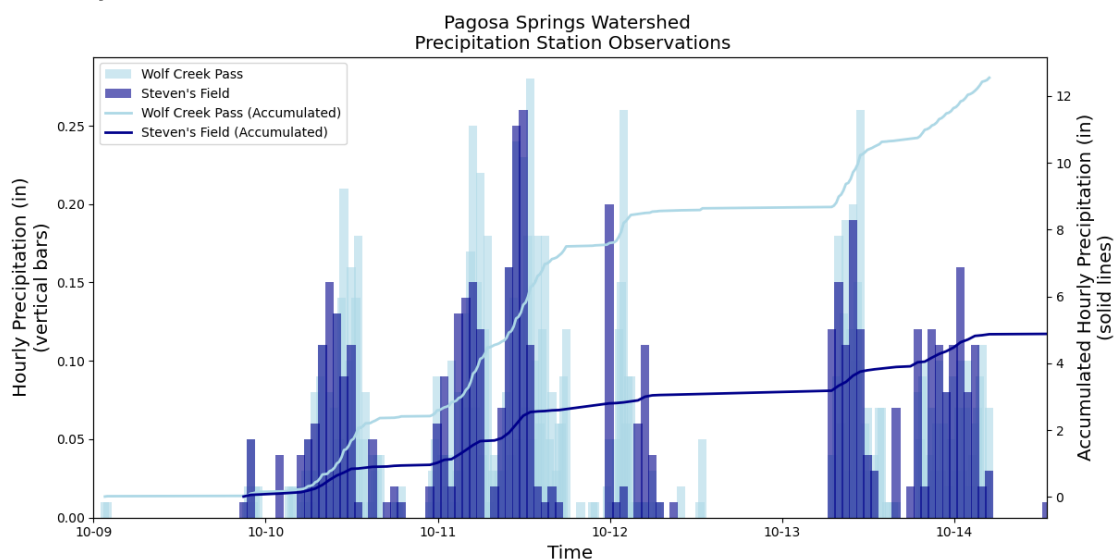
Figure 3. Observed precipitation near Pagosa Springs and in the high elevation region of the San Juan River basin. Hourly precipitation (left vertical axis) at the Wolf Creek Pass and Steven's field station are shown as light-blue and dark-blue bars respectively. Total accumulated precipitation starting October 9th (right vertical axis) is shown as a line with the same color scheme.

The first wave of the flood event began with the onset of precipitation falling in the San Juan River above the Pagosa Springs watershed (Figure 1) during the late evening of October 9th, which continued through most of the day on October 10th. During this time, a total of 1.02 inches of precipitation fell near the city of Pagosa Springs and 2.59 inches fell in the high elevation regions of the San Juan River watershed in the San Juan Mountains (Figure 3). This first full day of precipitation saturated the soils of the watershed above Pagosa Springs, meaning additional precipitation to come would primarily flow directly into the San Juan River.

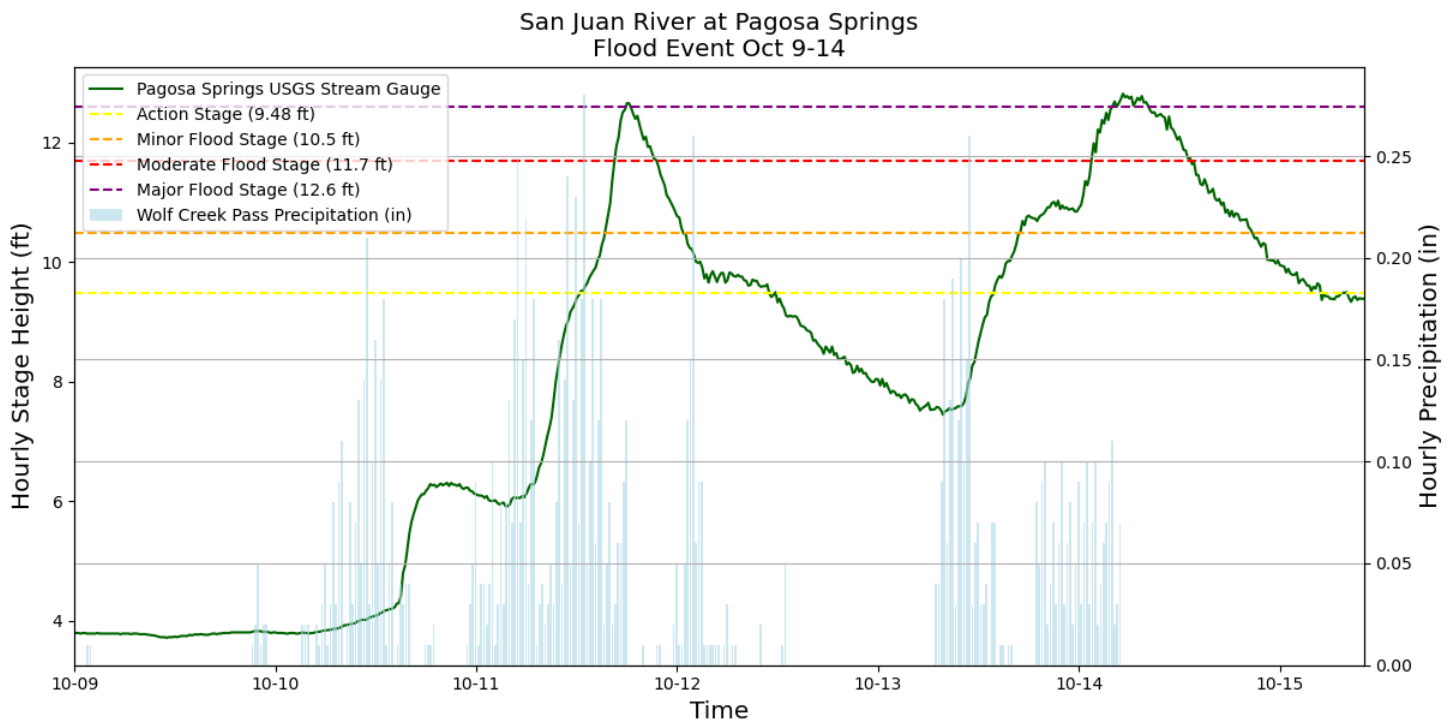
Figure 4. Hydrology of the flood events in Pagosa Springs from October 9th - 14th. Observed height of the water levels (left vertical axis) at the USGS stream gauge in Pagosa Springs is shown as the solid green line, with hourly precipitation that fell in the watershed above the gauge shown as blue vertical bars (right vertical axis). Flood stage thresholds are shown as horizontal dashed lines.

A break in precipitation during the night of October 10th was followed by near constant precipitation across the watershed in the early morning and throughout the next day, leaving a two-day total of 2.8 inches of precipitation near the city of Pagosa and 7.6 inches near Wolf Creek Pass. This heavy inundation of precipitation, particularly in the high elevation region of the basin, coincided with a steep rise in the river levels for the San Juan River in Pagosa Springs (Figure 4). The river reached Minor Flood stage (10.5 ft) at 3:30pm MDT on October 11th and climbed to Major Flood stage (12.6 ft) in just under two and a half hours, causing the river to flow out of its banks and into the floodplain, damaging roadways and water infrastructure³. The flood levels peaked at 6pm MDT in Pagosa Springs at 12.66 ft gauge height, effectively tripling the height of the river from just one day earlier (3.8 ft). At the time of peak flooding on October 11th, the river discharge was 8,270 cubic feet per second (cfs), a flow rate 94 times larger than the daily maximum flow rate of the San Juan River prior to the onset of the precipitation on October 9th.

The watershed experienced a slight reprieve in the precipitation on October 12th, accumulating only 0.26 inches of precipitation in the morning near Pagosa Springs and slightly more in the mountains. San Juan River levels dropped below Minor Flood Stage during the morning of October 12th and continued a slow decline through the morning of October 13th.

The full flooding event was not over yet. Continuous rainfall started in the late morning on October 13th and persisted through the morning of October 14th, initiating the river to reach even higher flood levels than were observed over the previous two days. The river again reached Minor Flood stage (10.5 ft) by 4pm on October 13th and Major Flood stage (12.6 ft) by 4am the following morning. The river would stay above that threshold for the next 4 hours. The second flood peak reached its maximum of 12.82 ft at 5:15am; at that time, 8,570 cubic feet of water was passing through the USGS stream gauge each second on the San Juan River in Pagosa Springs.

Soil moisture has a direct impact on the likelihood of a flood occurring in a watershed: when soil moisture is high, flooding can more easily occur. Multiple rain events sequenced together over a short period of time can serve as a bellwether for this increased flood risk (Figure 8)⁶. The October 2025 flooding in southwest Colorado was a clear demonstration of the impact of multiple sequential rain events on the magnitude and duration of a flood event. The first wave of precipitation, starting on the night of October 9th and persisting through the following day, saturated the soils in the San Juan River watershed above Pagosa Springs. When the second wave of rainfall started on October 11th, the soils were saturated with water, so additional rain went directly into surface runoff flowing into the San Juan River (Figure 4).

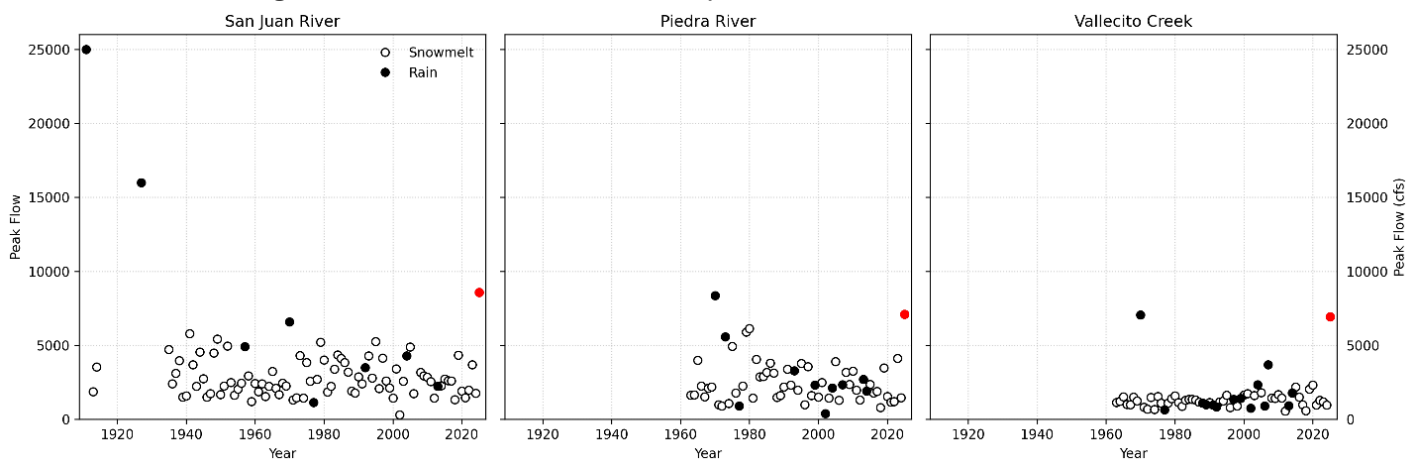
Figure 6. Annual peak flow in cubic feet per second (cfs) from the San Juan River at Pagosa Springs, the Piedra River near Arboles and Vallecito Creek near Bayfield. Open circles indicate peak flow is due to snowmelt, closed circles indicate peak flow is due to rain, and red circles indicate peak flow from the October 2025 flood. Data from USGS National Water Information System, Peak Streamflow for Colorado.

Extreme precipitation and flooding impacted other southwestern Colorado watersheds, including the Piedra River and Vallecito Creek, the two watersheds to the west of the Upper San Juan. In the Upper Piedra watershed, 5 to 9 inches of precipitation fell over the five days ending on October 14th, 2025. Like the San Juan River in Pagosa Springs, two peak flows occurred on the Piedra. The first occurred early on October 12th with a peak flow of 4,680 cfs and the second in the early morning October 14th with a peak flow of 7,240 cfs, the second highest flow on record (Figure 6). The highest recorded flow on the Piedra River occurred during the October 1970 flood with a peak flow of 8,370 cfs.

Extensive precipitation also fell in Vallecito Creek, a drainage west of the Piedra River. A total of 5 to 9 inches of precipitation was recorded across the observation stations at a high elevation SNOTEL site and rain gauges near Bayfield. In the early morning of October 11th, Vallecito Creek flow peaked at 6,920 cfs, the second highest flow recorded in 62 years. Only the October 1970 flood exceeded the flood flow

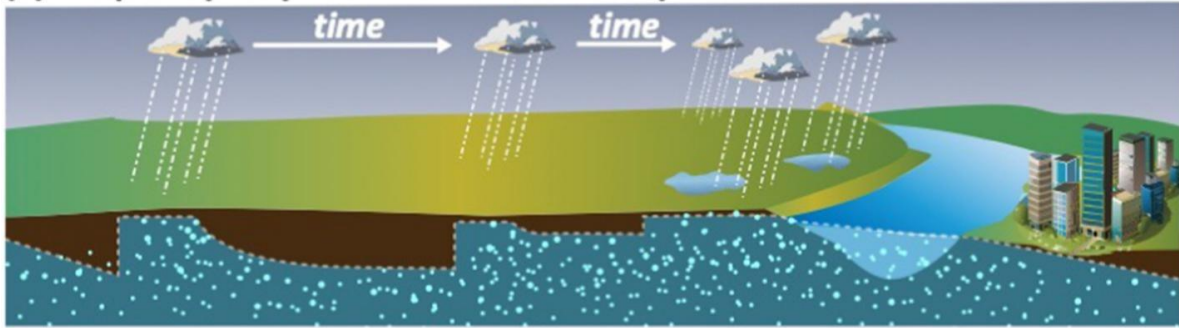
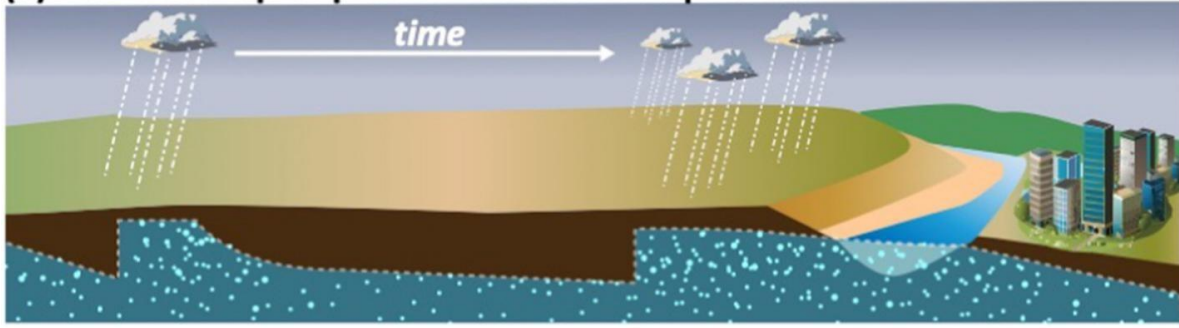
(a) Frequent precipitation enhances flood potential

(b) Intermittent precipitation reduces flood potential

Figure 8. Conceptual model of how frequent rain events influence flood probability. A study conducted by researchers of the Western Water Assessment team demonstrates how the timing, or intermittency, of precipitation could serve as a tool for flood prediction ⁶. **This figure was used with permission from the authors of the manuscript and can be found in its original publication here: <https://www.sciencedirect.com/science/article/pii/S0048969724039718>.*

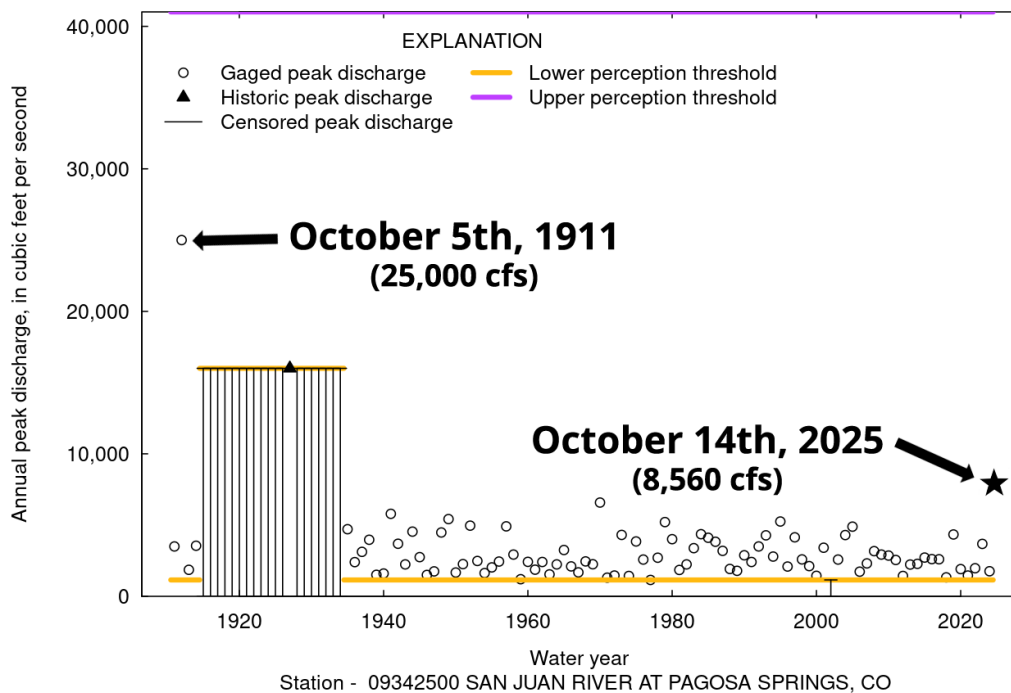
Figure 9. Annual maximum flood magnitudes for the San Juan River at Pagosa Springs. For the San Juan River at Pagosa Springs, all observed historical peak annual flows are shown as hollow points, and the Oct 2025 flood is annotated as a star. The peak annual flows from 1914-1934 (represented by vertical bars) were not directly observed and are estimated using a historical reference of the 1927 flood, these are considered in the flood frequency analysis but not as heavily weighted in the estimation of event probability. *This figure is derived from the USGS PeakFQ web application (<https://www.usgs.gov/tools/peakfq>)⁸ and annotated for clarity.

The October 2025 flood is the third largest flood on record for Pagosa Springs; the largest being the 1911 flood which also occurred in October and had nearly triple the discharge rate of the October 2025 flood at 25,000 cfs (Figure 9). To understand the likelihood of peak flood events like this, we can apply Flood Frequency Analysis methodologies that are designed to provide emergency planners with an assessment of the range of extreme flows that they should plan for. In this assessment, we apply the methods proposed by the USGS Bulletin 17c ⁷ to estimate the probability of the flood events that occurred from October 11th-14th, given the historical observations of flow in the San Juan River at Pagosa Springs from 1911 through 2024. Conducting this analysis using only the information from years prior to this most recent flood event grants insight into how likely a flood of this magnitude was to occur.

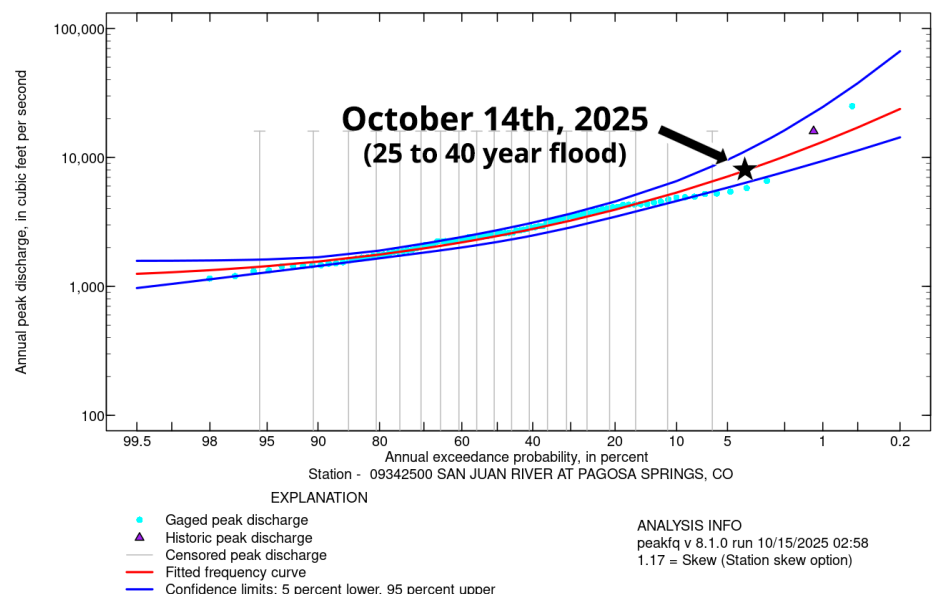
Figure 10. Flood frequency annual exceedance probability curve estimated for the San Juan River at Pagosa Springs. For the San Juan River at Pagosa Springs, the red curve represents the probability (in percentage; horizontal axis) that a flood of a given magnitude (cfs; vertical axis) or larger is likely to occur each year. The uncertainty of the statistical approach is represented by the bounding dark blue curves. All historical peak annual flows are shown as light blue points, 1927 flood that was estimated is shown as a triangle, and the Oct 2025 flood is annotated as a star. Station skew (here 1.17) is a description of the shape of the probability distribution of peak flows that occur at this specific USGS stream gauge.⁷ *This figure is derived from the USGS PeakFQ web application (<https://www.usgs.gov/tools/peakfq>)⁸ and annotated for clarity.

The return period for the October 2025 flood is estimated to be between 25 to 40 years based on annual maximum flow records for the San Juan River at Pagosa Springs, which means that probabilistically this event is likely to occur once every 25 to 40 years (Figure 10). Put another way, there is a 2.5 to 4% chance that a flood of this magnitude would occur during any given year. It is important when discussing such analyses to clarify that this is only probabilistic and not prescriptive of how often in the future flooding of this magnitude will actually occur. For example, it is entirely possible for a 40-year flood to occur two years in a row. Furthermore, this type of analysis relies on the assumption that the underlying drivers of floods (primarily precipitation intensity and quantities) will be statistically stationary in the future, which is unlikely to be a wholly valid assumption given regional trends in precipitation and temperature⁹. For reference, the 1911 flood has an estimated return period of 200 years meaning that there is a 0.5% chance of a flood of 25,000 cfs occurring in any given year.

Flood Frequency Analysis: Flood frequency analysis used in this report were derived from tools that rely on the methodologies described in USGS Bulletin 17c⁷. We use the PeakFQ Web Application (<https://www.usgs.gov/tools/peakfq>)⁸ that derives flood frequency curves from the annual maximum discharge recorded at the site of the Pagosa Springs stream gauge. Return periods are estimated by fitting a Pearson-III distribution to the annual maximum discharge values. In this case we rely on the station observations of all historical peak flows regardless of timing during the year and use the station skewness coefficient for simplicity and to provide a baseline estimation of the probability of the event.
