# Rapid Assessment of October 2025 Flooding in Southwest Colorado

Authors: Nels Bjarke and Seth Arens

WESTERN WATER  
ASSESSMENT  
A NOAA RISA TEAM

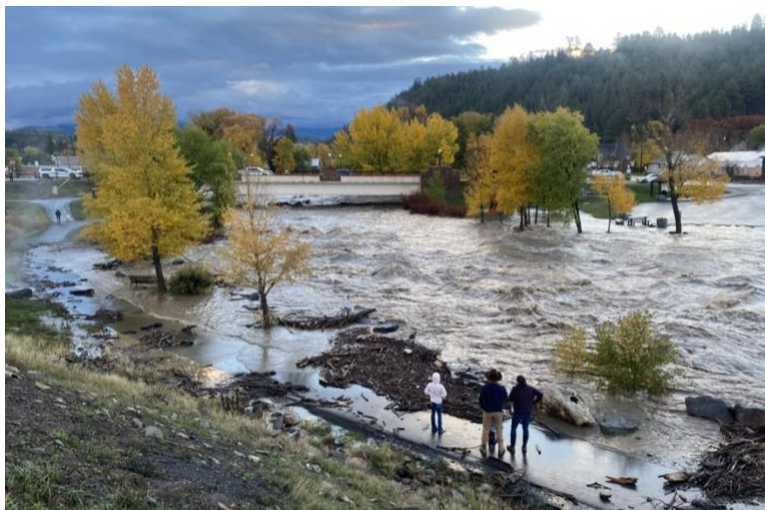
October 2025 flooding of the San Juan River at Pagosa Springs.  
Photo courtesy of Randi Pierce and The Pagosa Springs Sun<sup>1</sup>

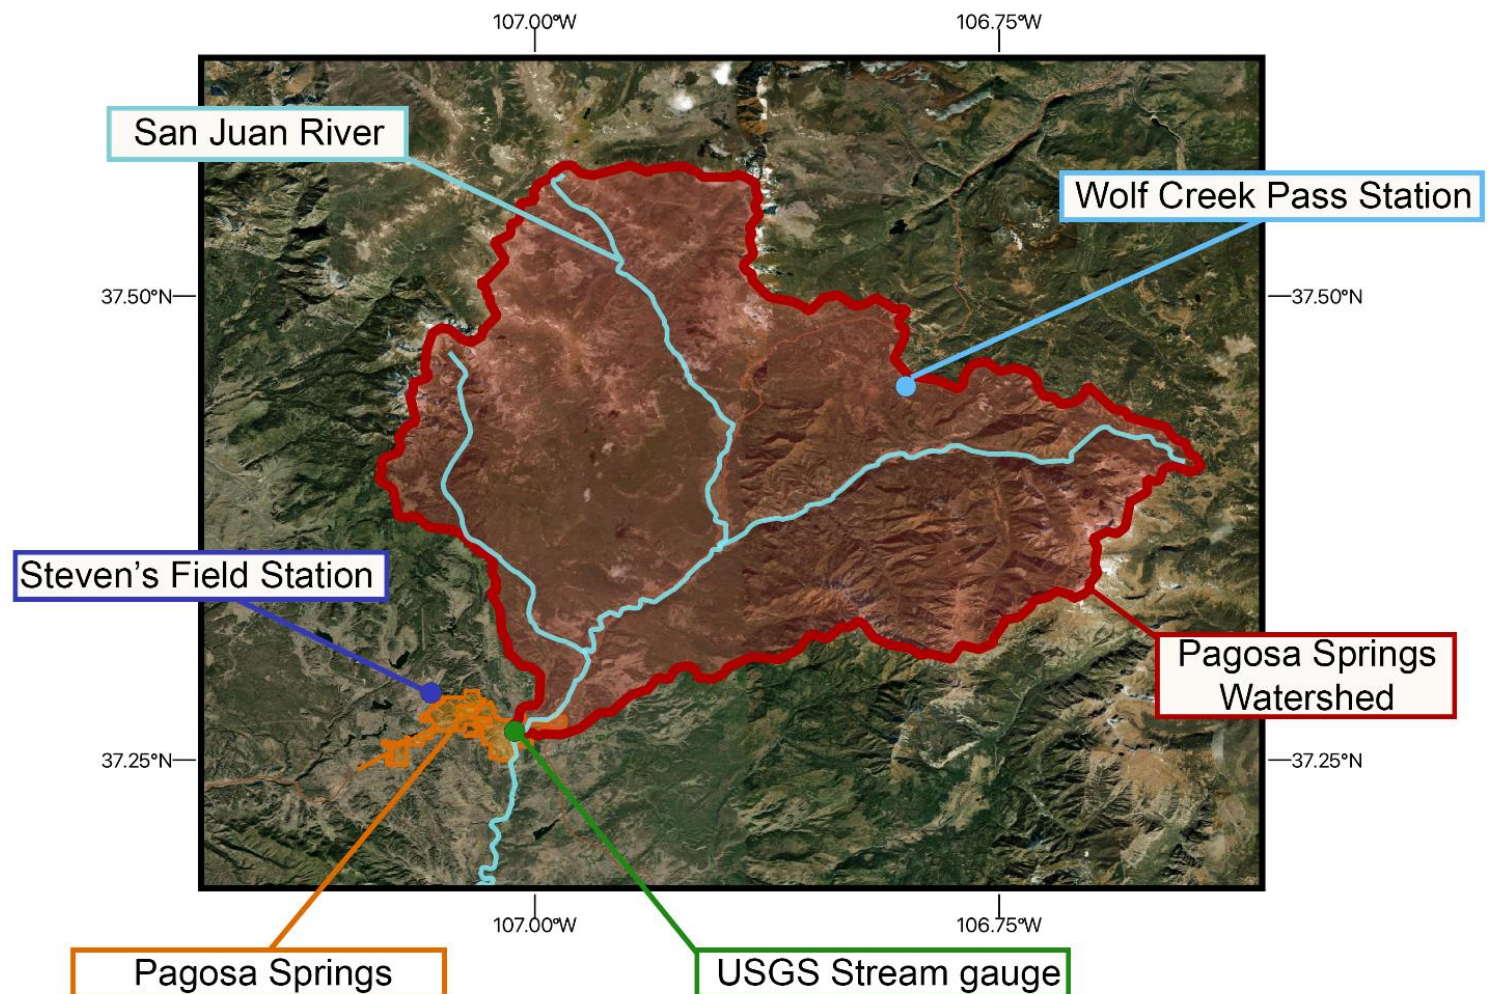
**Figure 1. Map of the watershed that contributes to the San Juan River above Pagosa Springs.** The map shows the area where falling precipitation would contribute to runoff that flows through the city of Pagosa Springs (red polygon), the municipal boundaries of Pagosa Springs (orange polygon), the precipitation monitoring stations used for the analysis in this report (Steven's Field-blue point; Wolf Creek Pass-light blue point), the USGS stream gauge located in Pagosa Springs (green point), and the path of the San Juan River and its tributaries (light blue line).

The San Juan River watershed above Pagosa Springs is an area of ~270 square miles (~700km<sup>2</sup>) nestled in the San Juan Mountains of southwest Colorado (Figure 1). The hydroclimate of the watershed above Pagosa Springs is emblematic of the semi-arid mountains of southwest Colorado and northwest New Mexico, with a majority of the annual runoff in the San Juan River coming from a winter snowpack that feeds the annual pulse of water in April through the early-mid summer. During late summer and early fall the San Juan River flows are usually low, but occasional monsoonal rains and remnants of tropical storms have historically delivered pulses of precipitation that can generate significant spikes in runoff.

**Watershed:** The watershed used in this report was delineated using the SRTM 1-arc second (~30m resolution) digital elevation model<sup>13</sup>. Flow direction and flow accumulation maps were generated for the region and all locations that flow into the location of the USGS stream gauge located in Pagosa Springs (latitude: 37.265527, longitude: -107.011) are included in the watershed shown in Figure 1.

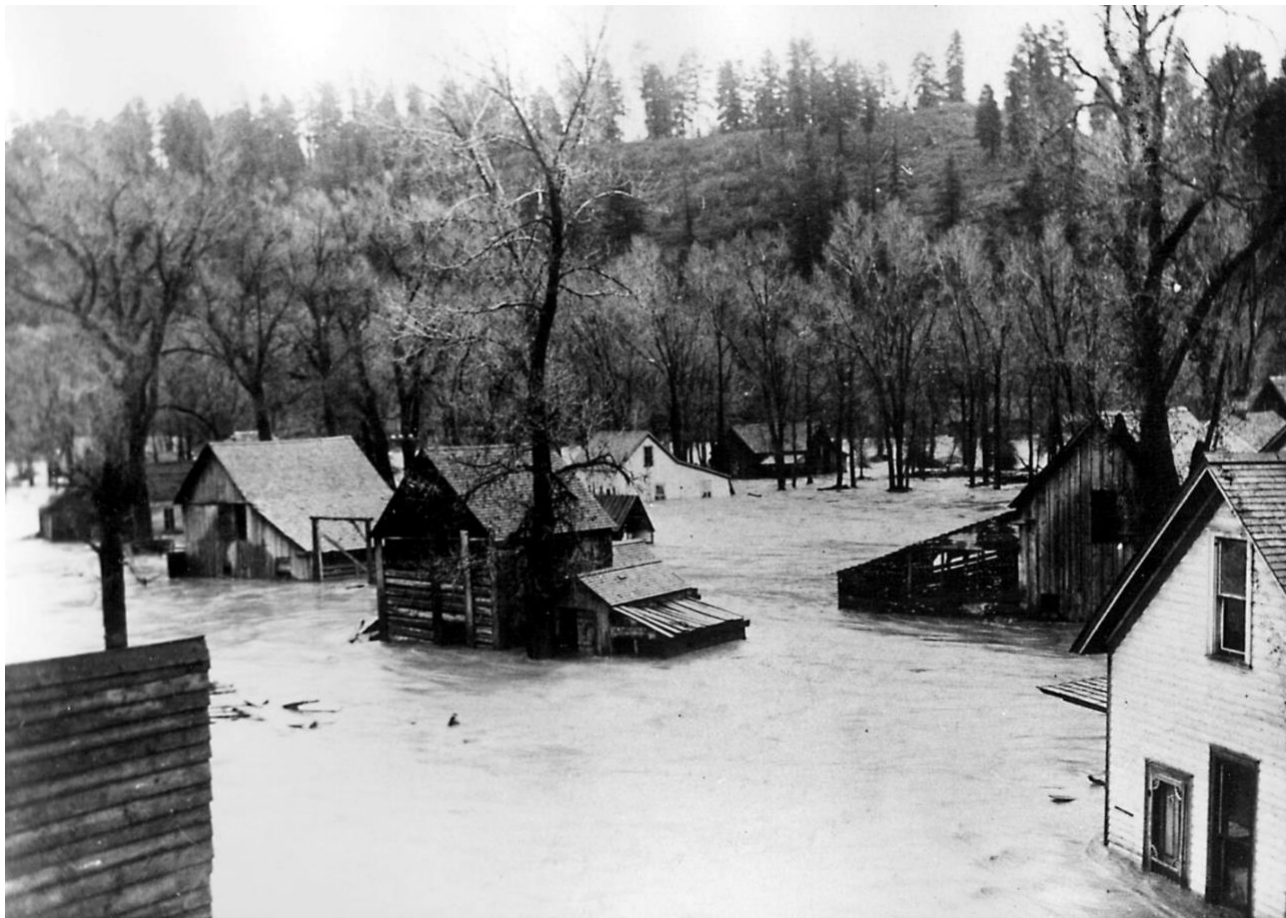
The October 1911 flood of the San Juan River in Pagosa Springs flooded many homes as the river crested at nearly 18 feet. (The Pagosa Springs Sun, October 16<sup>th</sup>, 2025)<sup>1</sup>

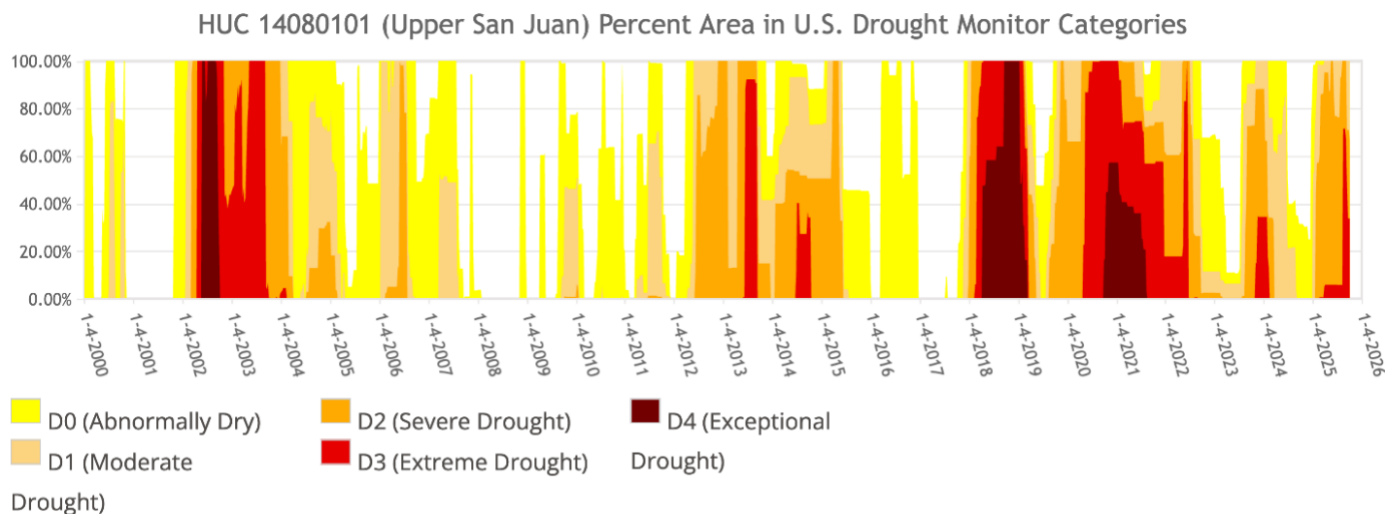
**Figure 2. U.S. Drought Monitor time series (2000-2025) for the Upper San Juan River basin.** Drought categories indicate the relative dryness of the atmosphere and land-surface compared to the historical record using a convergence of evidence approach developed by the U.S. Drought Monitor. (USDM Time Series, <https://droughtmonitor.unl.edu/DmData/TimeSeries.aspx>) The U.S. Drought Monitor is jointly produced by the National Drought Mitigation Center at the University of Nebraska-Lincoln, the United States Department of Agriculture, and the National Oceanic and Atmospheric Administration. Map courtesy of NDMC.

The San Juan River basin above Pagosa Springs was in moderate drought, in the lowest 20<sup>th</sup> percentile of historical moisture levels, during early October 2025 (U.S. Drought Monitor, October 7<sup>th</sup>, 2025, <https://droughtmonitor.unl.edu/Maps/MapArchive.aspx>). The Millennial Drought of the Western U.S. began in 2002 and was the most intense in the Upper San Juan River basin from 2002-2007, 2012-2015 and 2018 to present (Figure 2). Many of the last eight years of drought were experienced as extreme to exceptional drought in the basin, and drought was briefly alleviated during late 2024 through the early spring of 2025.

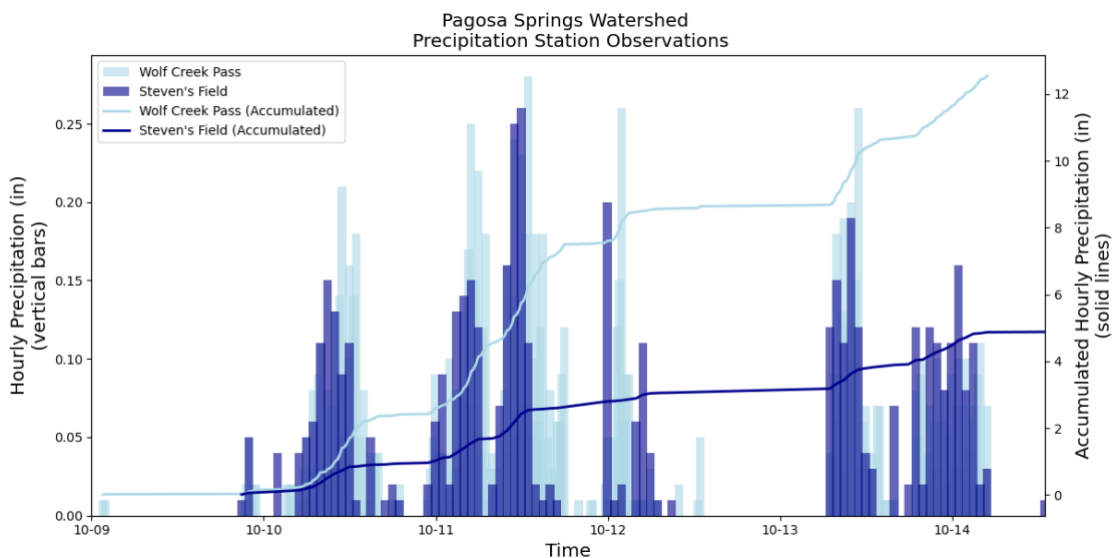
**Figure 3. Observed precipitation near Pagosa Springs and in the high elevation region of the San Juan River basin.** Hourly precipitation (left vertical axis) at the Wolf Creek Pass and Steven's field station are shown as light-blue and dark-blue bars respectively. Total accumulated precipitation starting October 9<sup>th</sup> (right vertical axis) is shown as a line with the same color scheme.

The first wave of the flood event began with the onset of precipitation falling in the San Juan River above the Pagosa Springs watershed (Figure 1) during the late evening of October 9<sup>th</sup>, which continued through most of the day on October 10<sup>th</sup>. During this time, a total of 1.02 inches of precipitation fell near the city of Pagosa Springs and 2.59 inches fell in the high elevation regions of the San Juan River watershed in the San Juan Mountains (Figure 3). This first full day of precipitation saturated the soils of the watershed above Pagosa Springs, meaning additional precipitation to come would primarily flow directly into the San Juan River.

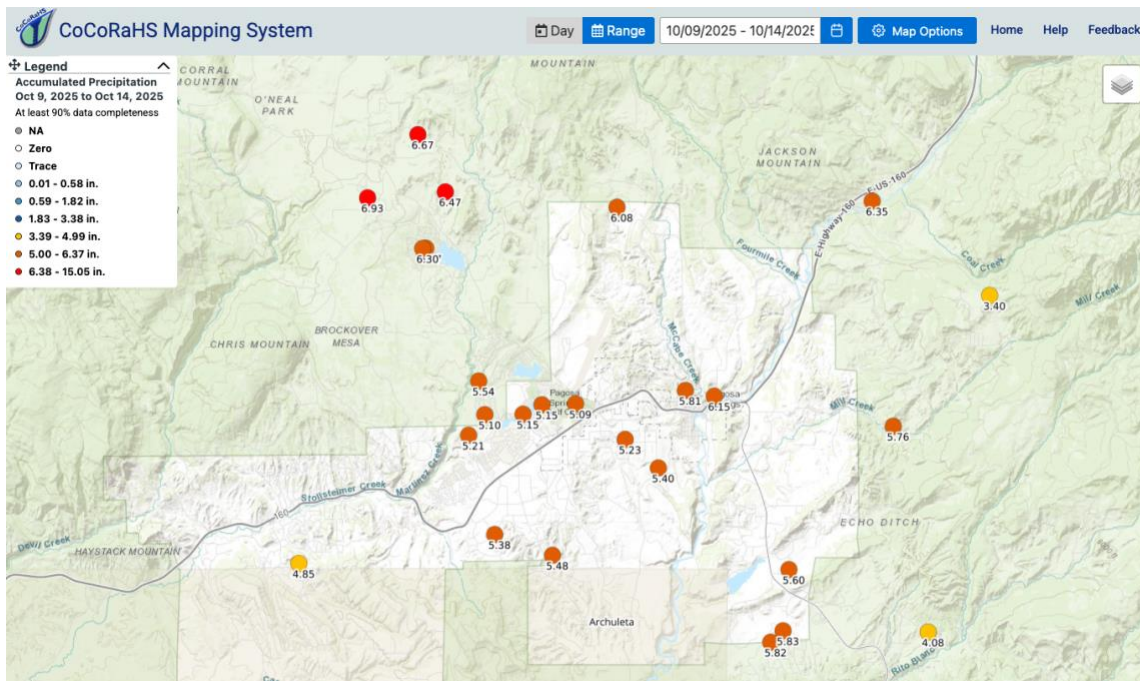
**Figure 5. Five-day precipitation (October 9<sup>th</sup>-14<sup>th</sup>, 2025) total for the Pagosa Springs area.** (CoCoRaHS Mapping System, <https://maps.cocorahs.org/>)

The watershed had received 4 to 5 inches of precipitation near the city of Pagosa Springs over the five days preceding the second flood peak (Figure 5) and 12.5 inches of precipitation in the mountains of the watershed that feeds into the city. Rain over the five-day period originated from the decaying remnants of Tropical Storms Priscilla and Raymond (for a detailed discussion of the meteorology for this event, see the [Colorado Climate Center post](#) <sup>4</sup>). From October 10<sup>th</sup>-14<sup>th</sup>, 2025 (a period of 5 days), 1.5 billion cubic feet of water flowed through the San Juan River at Pagosa Springs.

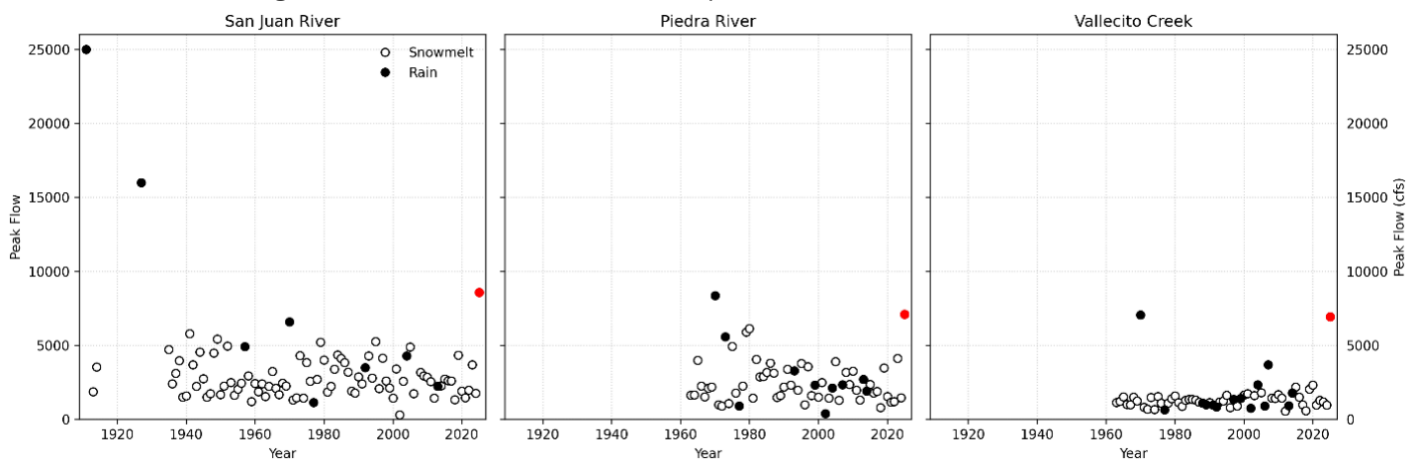
**Figure 6. Annual peak flow in cubic feet per second (cfs) from the San Juan River at Pagosa Springs, the Piedra River near Arboles and Vallecito Creek near Bayfield.** Open circles indicate peak flow is due to snowmelt, closed circles indicate peak flow is due to rain, and red circles indicate peak flow from the October 2025 flood. Data from USGS National Water Information System, Peak Streamflow for Colorado.

Extreme precipitation and flooding impacted other southwestern Colorado watersheds, including the Piedra River and Vallecito Creek, the two watersheds to the west of the Upper San Juan. In the Upper Piedra watershed, 5 to 9 inches of precipitation fell over the five days ending on October 14<sup>th</sup>, 2025. Like the San Juan River in Pagosa Springs, two peak flows occurred on the Piedra. The first occurred early on October 12<sup>th</sup> with a peak flow of 4,680 cfs and the second in the early morning October 14<sup>th</sup> with a peak flow of 7,240 cfs, the second highest flow on record (Figure 6). The highest recorded flow on the Piedra River occurred during the October 1970 flood with a peak flow of 8,370 cfs.

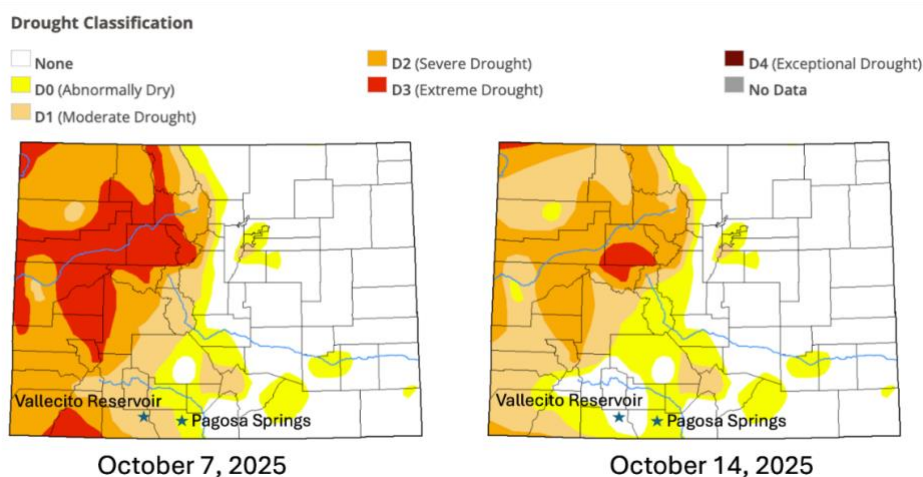
**Figure 7. U.S. Drought Monitor on October 7<sup>th</sup>, 2025 and October 14<sup>th</sup>, 2025 in Colorado.** (<https://droughtmonitor.unl.edu/Maps/CompareTwoWeeks.aspx>). The U.S. Drought Monitor is jointly produced by the National Drought Mitigation Center at the University of Nebraska-Lincoln, the United States Department of Agriculture, and the National Oceanic and Atmospheric Administration. Map courtesy of NDMC.

While the extreme rainfall damaged infrastructure in the region, the event bolstered regional water supplies, increasing storage capacity in several reservoirs. Vallecito Reservoir storage more than doubled from 29,000 acre-feet (af) on October 9<sup>th</sup> to 79,000 af by October 19<sup>th</sup>. Over the same period, both Navajo Reservoir on the San Juan River and Lake Powell on the Colorado River increased in storage by over 100,000 af. The early October rainfall was enough to remove drought conditions from Archuleta, Conejos, Hinsdale, Mineral, Rio Grande, San Juan and half of La Plata Counties (Figure 7).

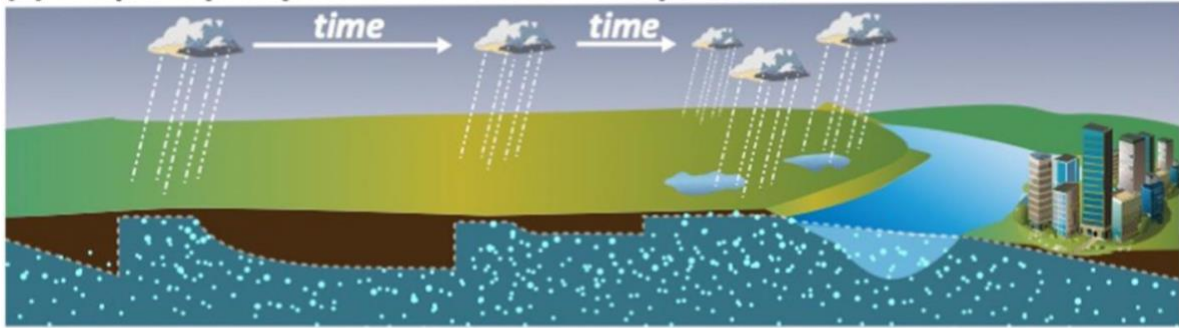
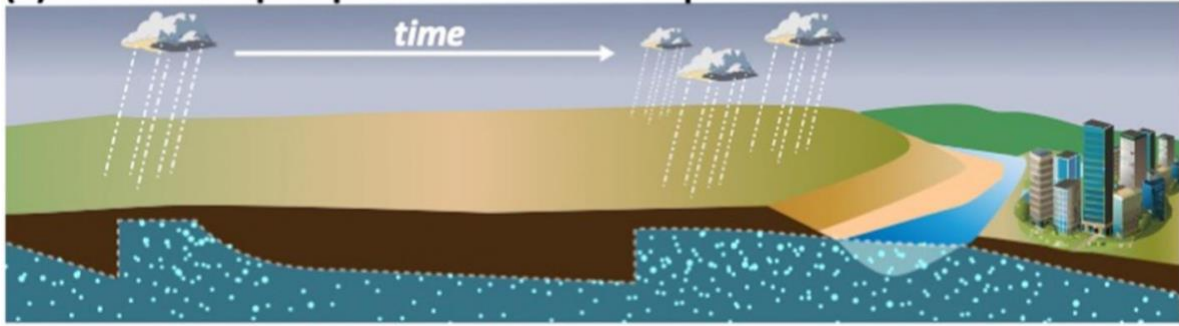
**(a) Frequent precipitation enhances flood potential**

**(b) Intermittent precipitation reduces flood potential**

**Figure 8. Conceptual model of how frequent rain events influence flood probability.** A study conducted by researchers of the Western Water Assessment team demonstrates how the timing, or intermittency, of precipitation could serve as a tool for flood prediction<sup>6</sup>. *\*This figure was used with permission from the authors of the manuscript and can be found in its original publication here: <https://www.sciencedirect.com/science/article/pii/S0048969724039718>.*

Soil moisture has a direct impact on the likelihood of a flood occurring in a watershed: when soil moisture is high, flooding can more easily occur. Multiple rain events sequenced together over a short period of time can serve as a bellwether for this increased flood risk (Figure 8)<sup>6</sup>. The October 2025 flooding in southwest Colorado was a clear demonstration of the impact of multiple sequential rain events on the magnitude and duration of a flood event. The first wave of precipitation, starting on the night of October 9<sup>th</sup> and persisting through the following day, saturated the soils in the San Juan River watershed above Pagosa Springs. When the second wave of rainfall started on October 11<sup>th</sup>, the soils were saturated with water, so additional rain went directly into surface runoff flowing into the San Juan River (Figure 4).

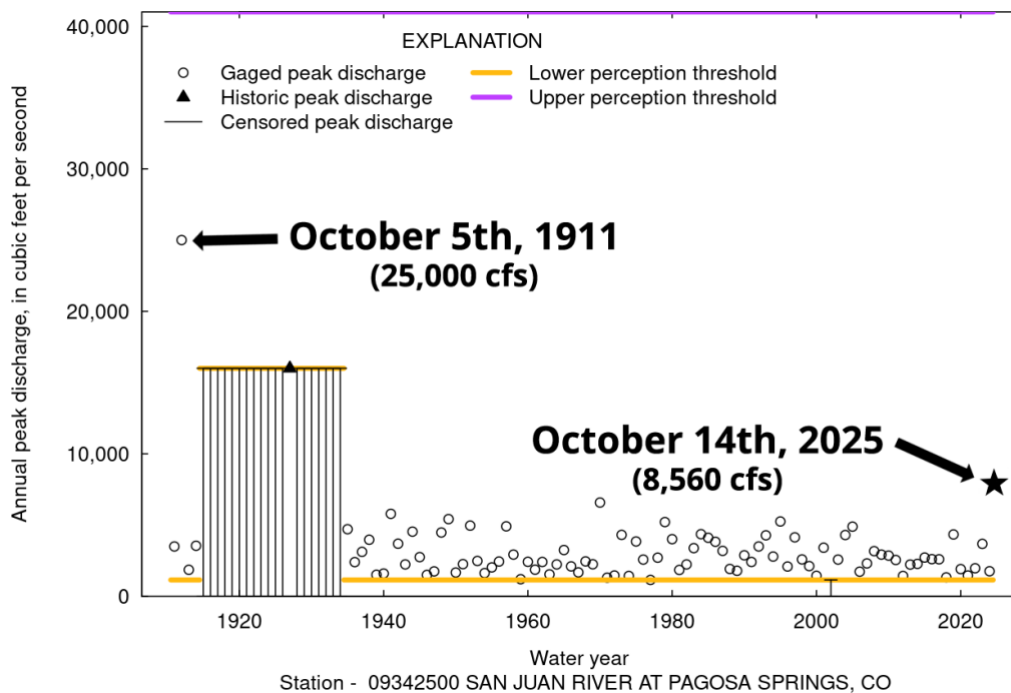
**Figure 9. Annual maximum flood magnitudes for the San Juan River at Pagosa Springs.** For the San Juan River at Pagosa Springs, all observed historical peak annual flows are shown as hollow points, and the Oct 2025 flood is annotated as a star. The peak annual flows from 1914-1934 (represented by vertical bars) were not directly observed and are estimated using a historical reference of the 1927 flood, these are considered in the flood frequency analysis but not as heavily weighted in the estimation of event probability. \*This figure is derived from the USGS PeakFQ web application (<https://www.usgs.gov/tools/peakfq>)<sup>8</sup> and annotated for clarity.

The October 2025 flood is the third largest flood on record for Pagosa Springs; the largest being the 1911 flood which also occurred in October and had nearly triple the discharge rate of the October 2025 flood at 25,000 cfs (Figure 9). To understand the likelihood of peak flood events like this, we can apply Flood Frequency Analysis methodologies that are designed to provide emergency planners with an assessment of the range of extreme flows that they should plan for. In this assessment, we apply the methods proposed by the USGS Bulletin 17c<sup>7</sup> to estimate the probability of the flood events that occurred from October 11<sup>th</sup>-14<sup>th</sup>, given the historical observations of flow in the San Juan River at Pagosa Springs from 1911 through 2024. Conducting this analysis using only the information from years prior to this most recent flood event grants insight into how likely a flood of this magnitude was to occur.

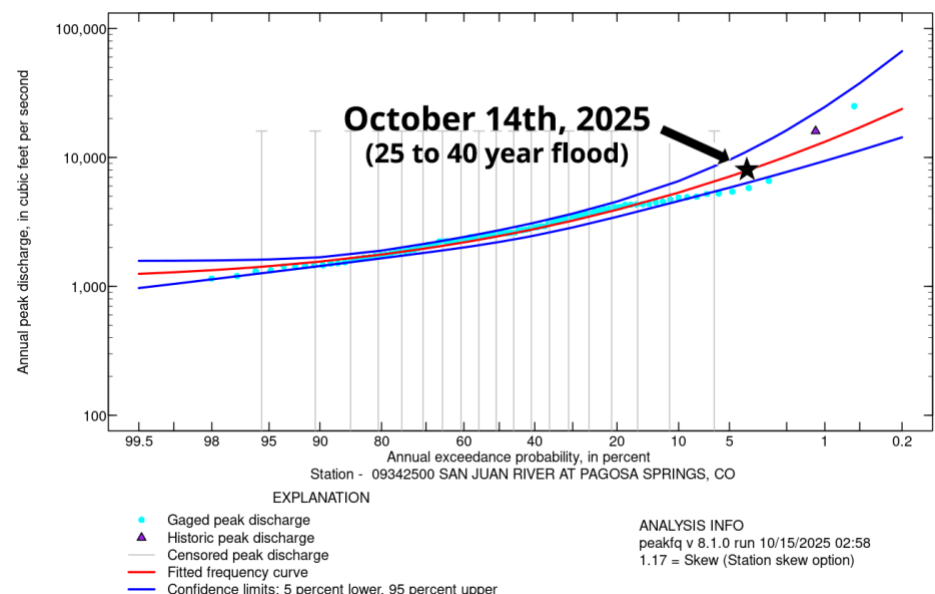
**Figure 10. Flood frequency annual exceedance probability curve estimated for the San Juan River at Pagosa Springs.** For the San Juan River at Pagosa Springs, the red curve represents the probability (in percentage; horizontal axis) that a flood of a given magnitude (cfs; vertical axis) or larger is likely to occur each year. The uncertainty of the statistical approach is represented by the bounding dark blue curves. All historical peak annual flows are shown as light blue points, 1927 flood that was estimated is shown as a triangle, and the Oct 2025 flood is annotated as a star. Station skew (here 1.17) is a description of the shape of the probability distribution of peak flows that occur at this specific USGS stream gauge.<sup>7</sup> \*This figure is derived from the USGS PeakFQ web application (<https://www.usgs.gov/tools/peakfq>)<sup>8</sup> and annotated for clarity.

The return period for the October 2025 flood is estimated to be between 25 to 40 years based on annual maximum flow records for the San Juan River at Pagosa Springs, which means that probabilistically this event is likely to occur once every 25 to 40 years (Figure 10). Put another way, there is a 2.5 to 4% chance that a flood of this magnitude would occur during any given year. It is important when discussing such analyses to clarify that this is only probabilistic and not prescriptive of how often in the future flooding of this magnitude will actually occur. For example, it is entirely possible for a 40-year flood to occur two years in a row. Furthermore, this type of analysis relies on the assumption that the underlying drivers of floods (primarily precipitation intensity and quantities) will be statistically stationary in the future, which is unlikely to be a wholly valid assumption given regional trends in precipitation and temperature<sup>9</sup>. For reference, the 1911 flood has an estimated return period of 200 years meaning that there is a 0.5% chance of a flood of 25,000 cfs occurring in any given year.

**Flood Frequency Analysis:** Flood frequency analysis used in this report were derived from tools that rely on the methodologies described in USGS Bulletin 17c<sup>7</sup>. We use the PeakFQ Web Application (<https://www.usgs.gov/tools/peakfq>)<sup>8</sup> that derives flood frequency curves from the annual maximum discharge recorded at the site of the Pagosa Springs stream gauge. Return periods are estimated by fitting a Pearson-III distribution to the annual maximum discharge values. In this case we rely on the station observations of all historical peak flows regardless of timing during the year and use the station skewness coefficient for simplicity and to provide a baseline estimation of the probability of the event.
